**ACCESSIBILITY AUDIT OF BRT STATIONS FOR THE ELDERLY, THE
DISABLED AND FOR CHILDREN**

In this study the stations of BRT which is a very important public transport system in Istanbul will be examined in terms of accessibility. The aim of the study is to examine what should be done for disabled accessibility at BRT stations by using examples of accessible and inaccessible stations in the Istanbul BRT system. The second part of the study looks at accessibility at transfer stations. The stations chosen for the study are Edirnekapı station as a problematic station in terms of disabled accessibility, Beylikdüzü Belediye station as successful and Zeytinburnu station as a transfer center where BRT, tramway, and LRT intersect.

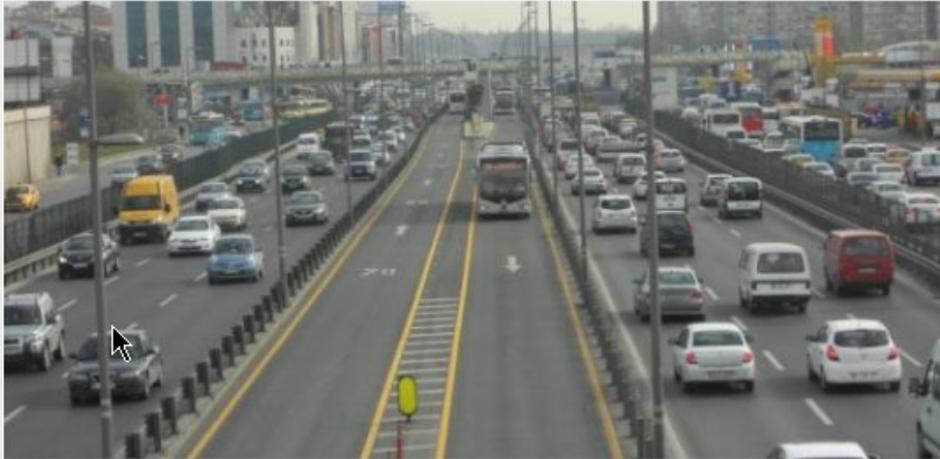
Figure 1. BRT system in Istanbul

In this study accessibility of BRT stations in Istanbul will be discussed. The BRT system has entered Istanbul's public transportation system in 2007 with 18,2 km route length and with 14 stations. Today the system serves with 52 km route length and 45 stations. One of the most important bottlenecks of Istanbul is the Bosphorus crossing. The Bosphorus divides the city into two parts, and until the 3rd phase of the BRT the city did not have an integrated transport network across the Bosphorus. As a rubber tired transportation mode the BRT crosses the bridge easily. Daily ridership of the system is more than that of many railway systems in Istanbul or in Turkey. The system carries 800.000 passengers/day.

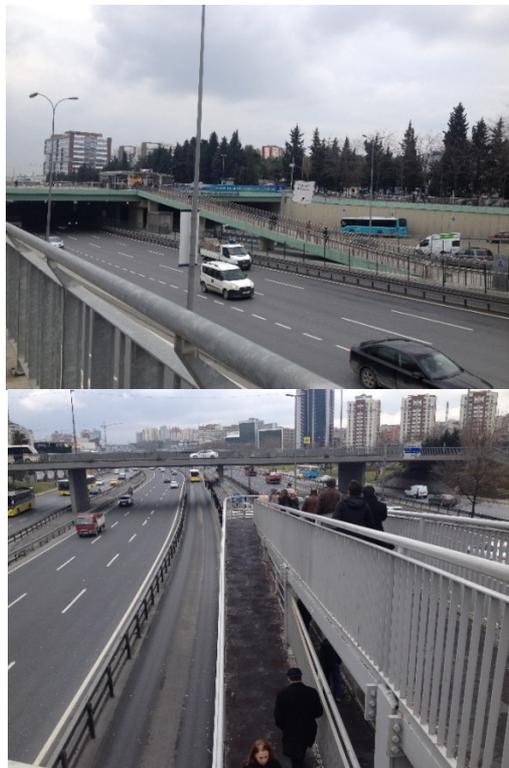
Figure 5. Examples for Ramps from Stations

In order to be accessible for all, a station must have an elevator or ramp at all three critical points. But having elevators does not mean that the station is accessible, because elevators need to be maintained periodically, otherwise they do not function reliably. Also elevators should be located at an accessible point of the station. There should be no obstacle on the path to the elevator. Thus it is always advantageous to have ramps at stations. They can serve users under any weather condition with little and infrequent need for maintenance.

The presence of escalators and elevators makes stations seemingly accessible but if these are not functioning properly they do not make the station accessible. Thus it is always better to have ramps at stations. Since they do not have mechanical components they need only occasional maintenance. There are no disruptions to accessibility as can be the case with broken-down elevators and escalators.

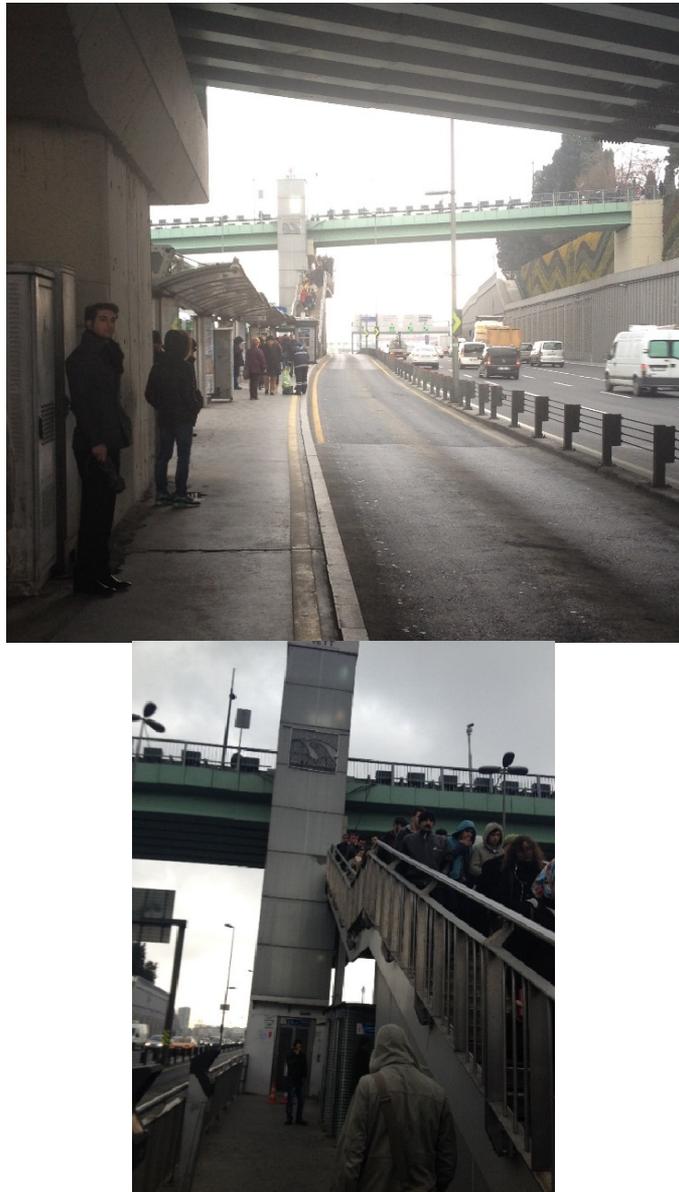
Figure 7. Accessibility Difficulties at Edirnekapı Station

In this study Edirnekapı Station is examined as the most problematic station with regard to accessibility. What makes this station different from others is the height of the overpass. Also there is only one elevator at the platform which does not meet the demand. There is no escalator. It is very difficult for any person to climb up the stairs even if the person has no disability. During the field survey it was observed that the station was very crowded even during off-peak hours. Thus accessibility improvements should be done at this station immediately.

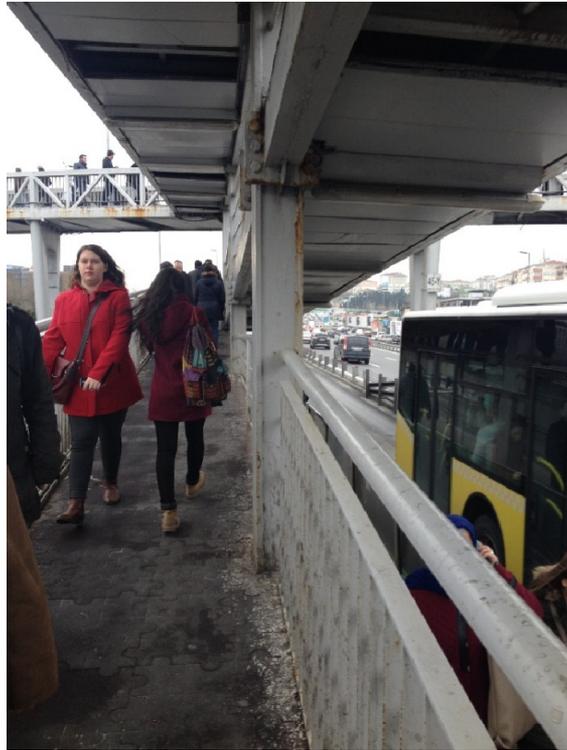
Zeytinburnu station is one of the most important transfer centers on the European side. Many different transport modes intersect here, including BRT, LRT, tram and minibus stations, İETT bus stations and the 'Park and Ride' facility. Thus all these modes should be integrated carefully. During this study it was observed that Zeytinburnu station has good integration with LRT, tram, İETT buses, minibuses and Park and Ride. Using ramps as a means of integration has provided continuous accessibility between different modes.

Figure 8. Zeytinburnu station, Access ramp from platform to overpass .

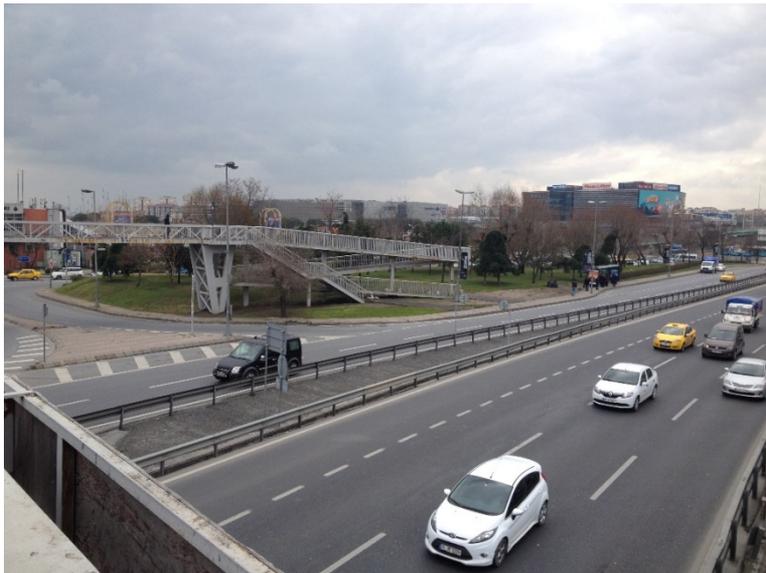
Figure 9. Access ramp to south service road and integration with İETT bus station.

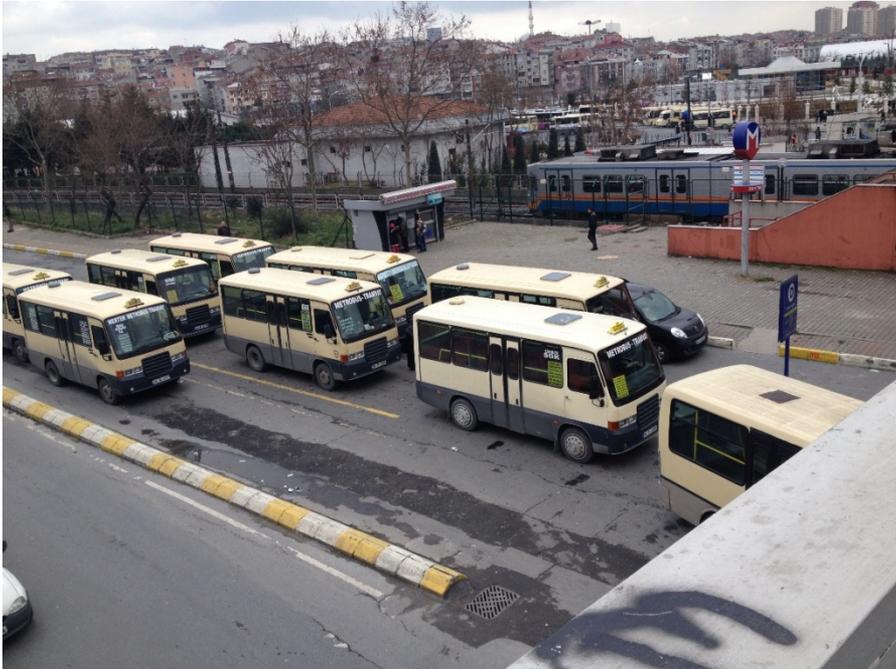
Figure 10. BRT's integration with minibuses is provided via elevators
