Sigma Journal of Engineering and Natural Sciences Sigma Mühendislik ve Fen Bilimleri Dergisi

Research Article

GROUNDWATER QUALITY MONITORING OF A SIGNIFICANT HABITAT IN TRAKYA UNIVERSITY: BALKAN ARBORETUM AREA (EDIRNE, TURKEY)

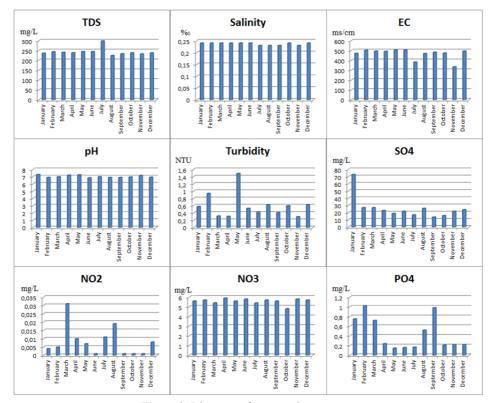
Figure 2. Diagrams of measured parameters

Groundwater quality parameters determined in Güllapoğlu Well are given in Table 1 and Figure 2 and some national – international limit values are given in Table 2.

No significant differences were found during the year except nitrite and phosphate parameters in general. It is thought that the rise in phosphate parameter especially in January, February, March and September and the rise in nitrite parameter especially in March were due to excessive rainfall and increase in drainage from agricultural lands to the underground.
